CITY OF EVANSTON

**SHORELINE
IMPLEMENTATION
ROADMAP**

SMITHGROUP

10/16/2020

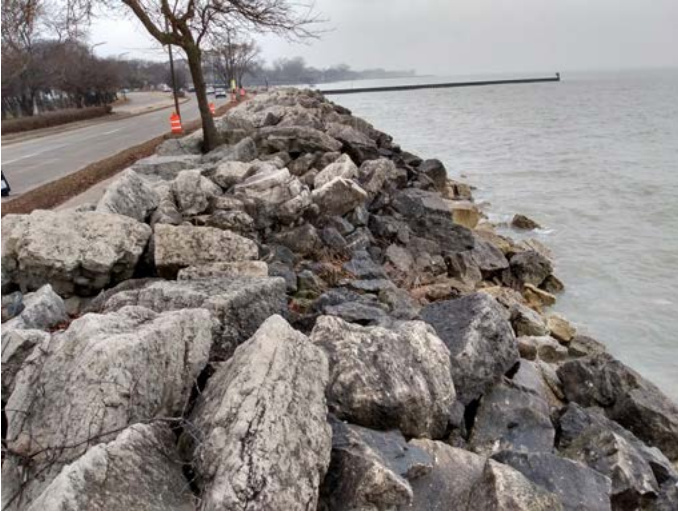
SHERIDAN ROAD REVETMENT

Individual stones in the revetment have deteriorated, disintegrated, or been dislodged leaving gaps in the crest, which allow waves to reach Sheridan Road during storms.

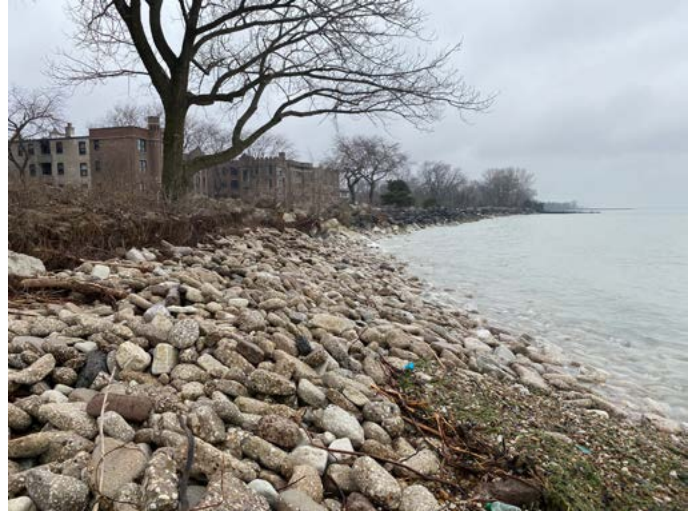
SOUTH BOULEVARD BEACH

Significant erosion has occurred at South Boulevard Beach resulting in exposed cobble and rubble.

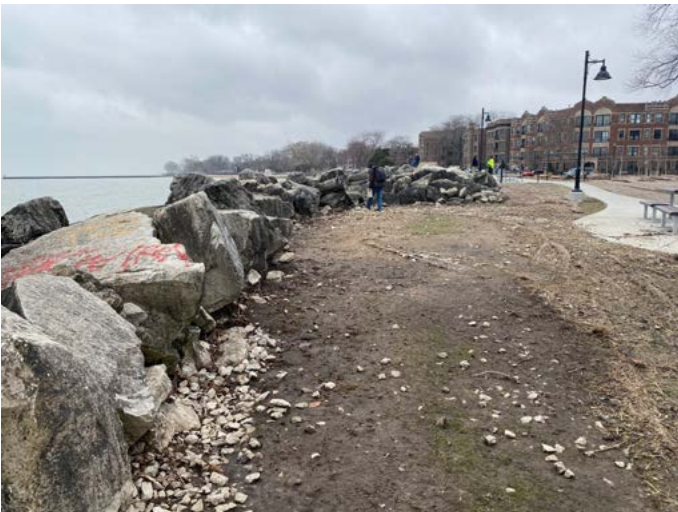
GARDEN PARK

Waves overtop the narrow revetment at the north end of Garden Park, causing damage on the landside.

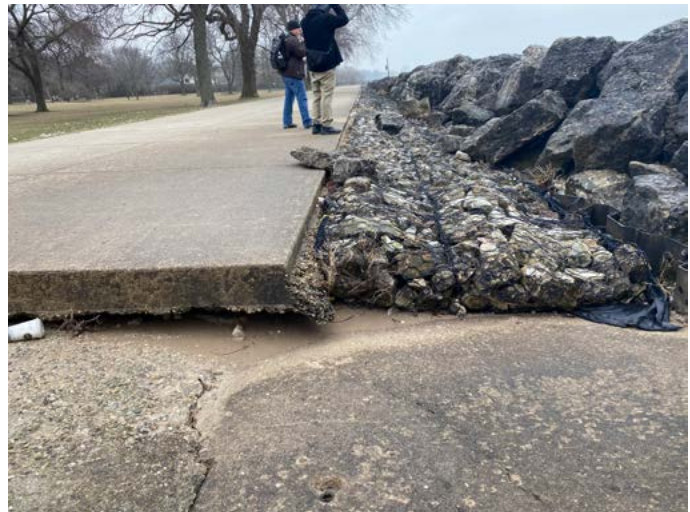
CLARK SQUARE

The gabions (stone-filled wire baskets) behind the armor stone and sheetpile are deteriorating, and overtopping water washes the smaller stone into the park and causes erosion.

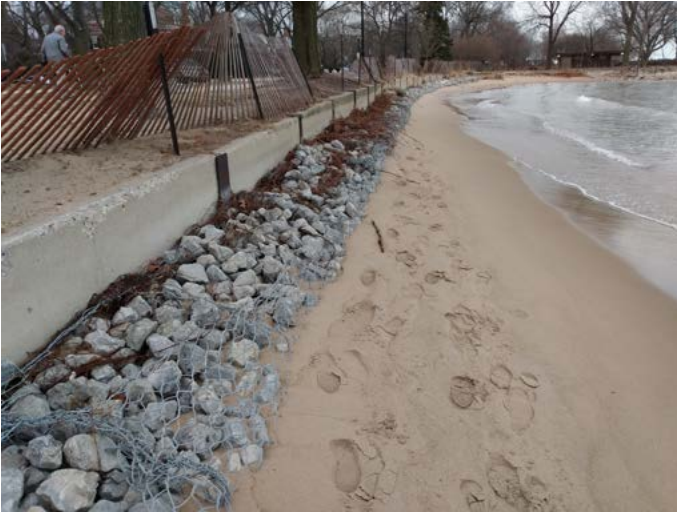
LEE STREET BEACH

The concrete wall and gabions have been exposed at the north end of Lee Street Beach, where there is very little dry beach width. The gabions are in poor condition, with several broken wire baskets.

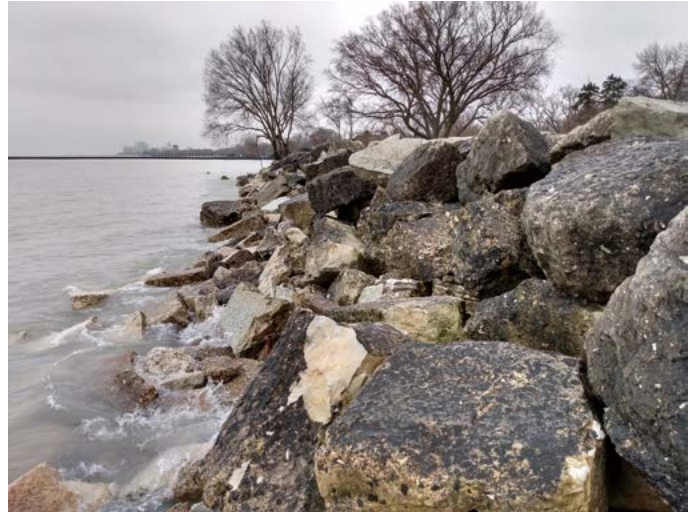
ELLIOT PARK - SOUTH

The revetment at Elliot Park is in poor condition, with a low, narrow crest and several examples of disintegrated stone fragments, which are easily dislodged during storms.

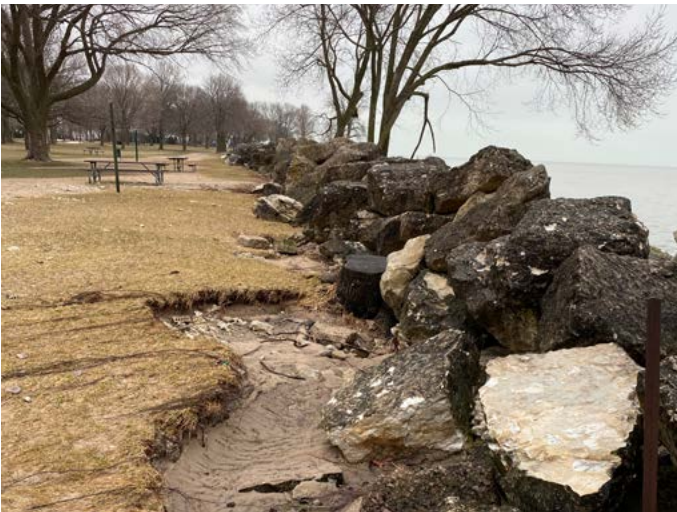
ELLIOT PARK - SOUTH

Waves overtopping revetment has caused erosion along the edge of the park and undermines stability of the revetment.

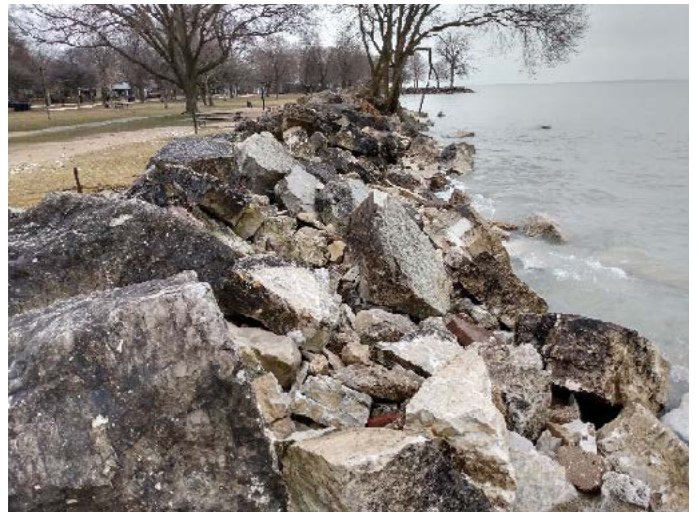
ELLIOT PARK - NORTH

Revetment is steep and many stones appear unstable.

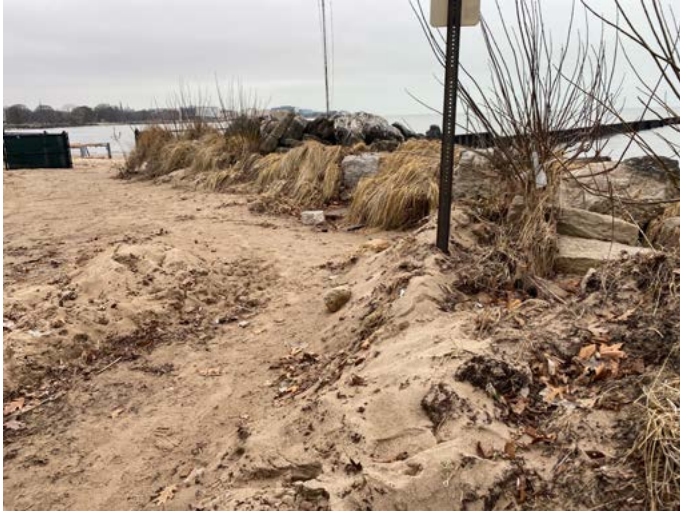
DEMPSTER STREET FACILITY

Dunes have deteriorated and substantial amounts of sand has been transported towards the Launch Facility

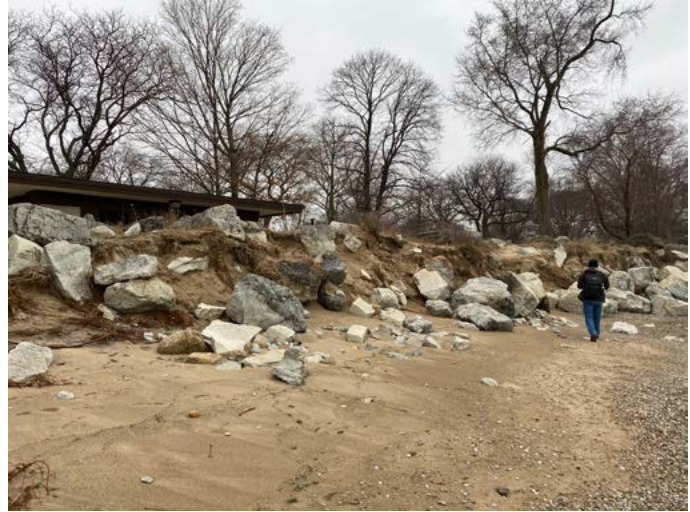
GREENWOOD BEACH

Revetment protecting the bathroom building at Greenwood Beach has reached the end of its useful life. Armor stone has deteriorated and been displaced.

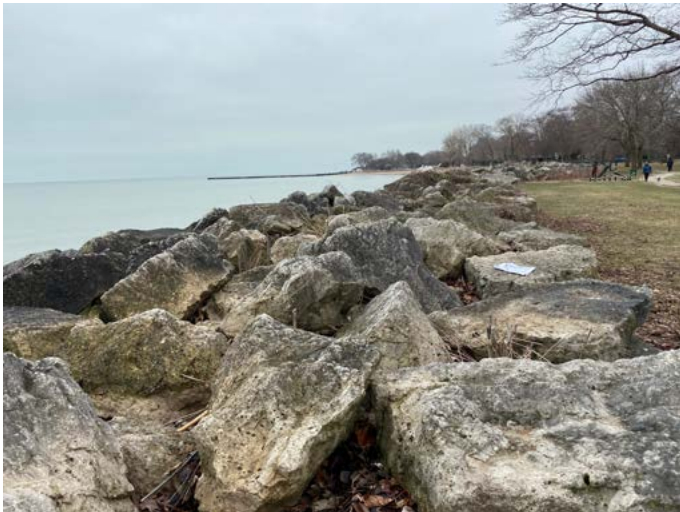
DAWES PARK

At the northern end of Dawes Park the revetment crest is relatively wide and the individual stones in reasonable condition. However, the crest here is lower than in other parts of the system.

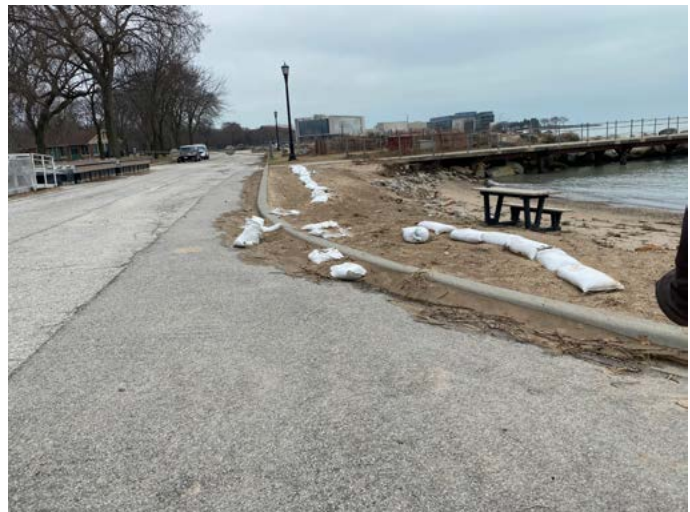
CHURCH STREET LAUNCH RAMP

Significant sand build up at the boat launch ramp and driveway.

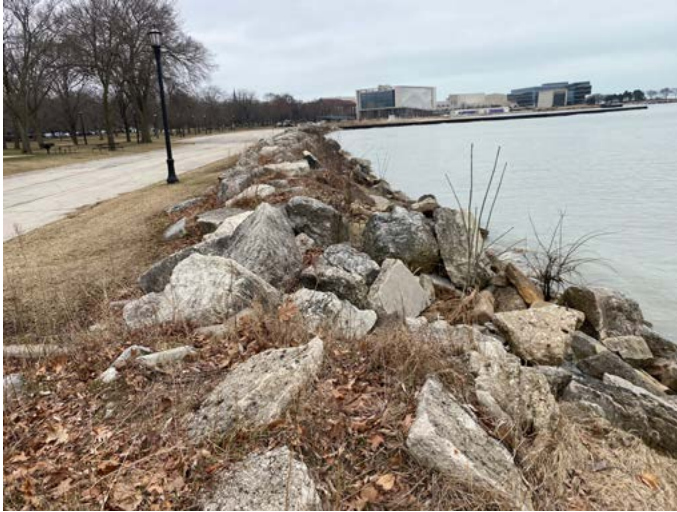
DOG BEACH

Revetment stone has been augmented with smaller pieces of broken concrete. There appear to be significant gaps between the revetment stones.

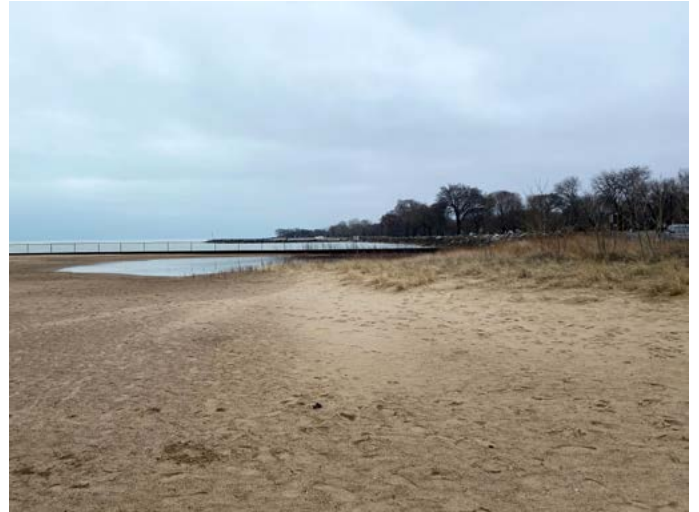
CLARK STREET BEACH

Sand displacement has caused low spots on the beach for water to collect as well as higher elevation dune features. This is a common phenomenon at wider beaches in the area (for example Montrose Beach in Chicago)

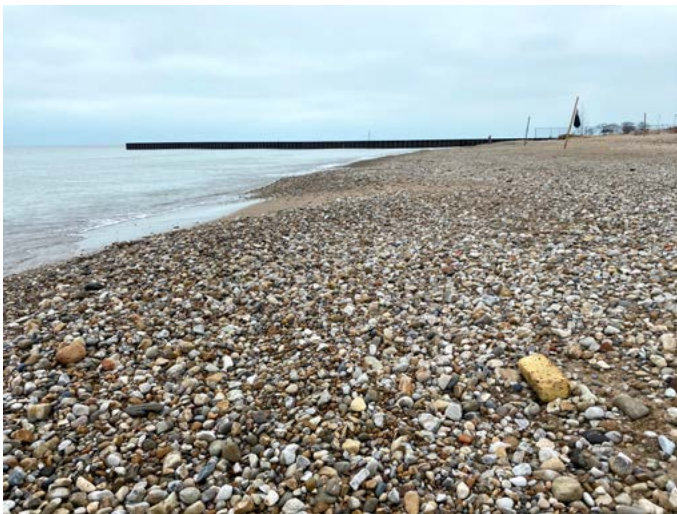
LIGHTHOUSE BEACH

Significant stone and gravel buildup was present at the lower portion of beach profile

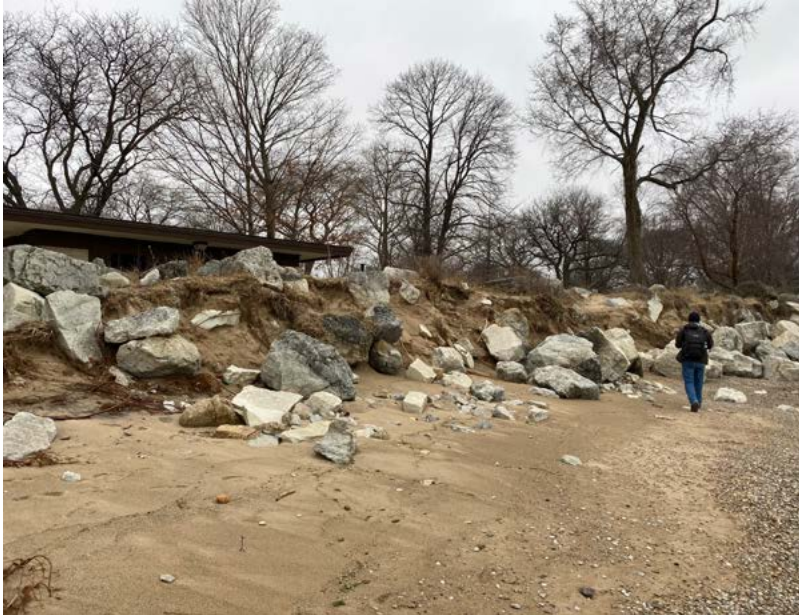
Condition: Narrow dry beach width with a relatively steep beach profile above the water line. Significant bluff damage with a near vertical scoured slope, above head high, with scattered large stone lakeward of the bluff. Cobble and gravel size material are also present near the water line. Scoured bluff presents a potential safety concern to pedestrian in the vicinity of the toe of slope. Low beach crest and width can be easily overtopped during storm events.

Figure 1-1 Erosion at Greenwood Beach (March 2020)

- Recommendation - Revetment stabilization and temporary flood barriers
 - Stabilize and add new armor stone to the revetment immediately in front of the building.
 - Install temporary flood protection (e.g. “TrapBag” barriers) extending south from revetment to limit overtopping damage, and reduce wind-blown sand transport.

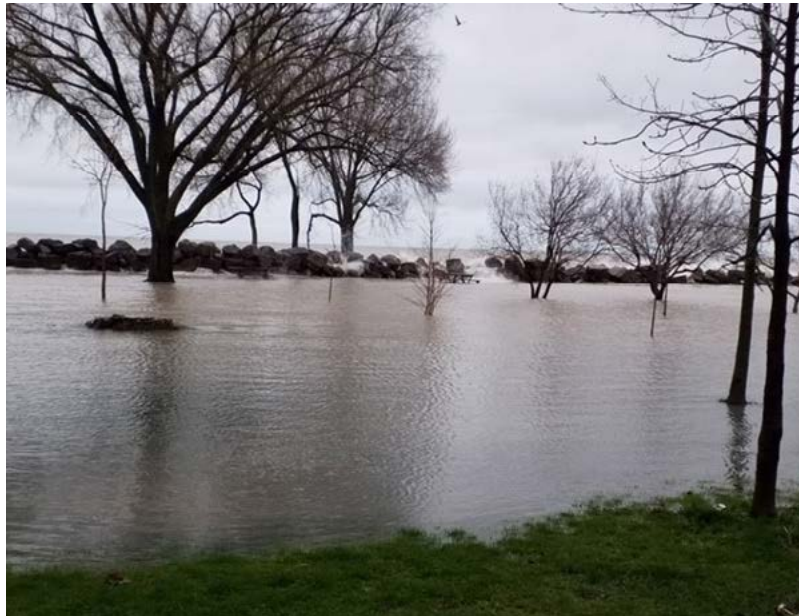
Condition: Loss of stone on slope and at the top of bank resulting in significant overtopping of the shoreline and flooding of the adjacent park and facilities. Overtopping results in erosion of the landward side of the revetment, transport of sand and other debris into the adjacent park facilities and ponding of water in large portions of the park. Scour at the landward limit of the revetment has the potential to undermine the revetment while the other impacts of overtopping present a maintenance and potential safety concern to park users.

Figure 1-2 Flooding at Elliot Park (April 2020)

- Recommendation - Revetment stabilization and temporary flood barriers
 - Stabilize existing armor stone above the water line
 - Install temporary flood protection (e.g. “TrapBag” barriers) extending from north end of Lee Street Beach to approx. mid-point of Elliot Park

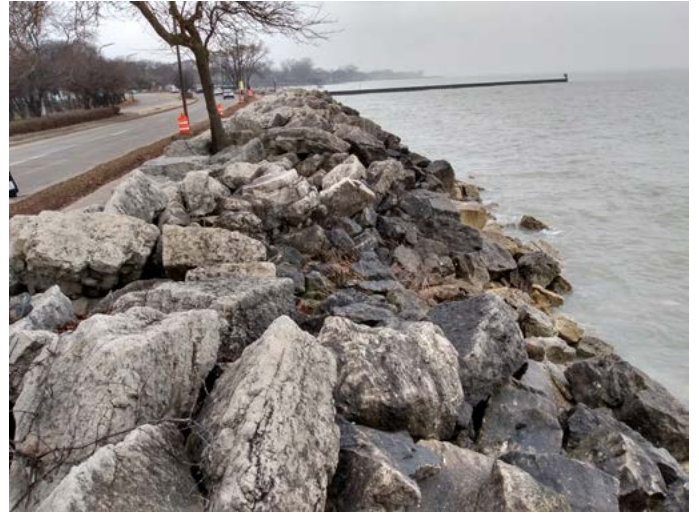
Image 2: Widening crest protection moving north

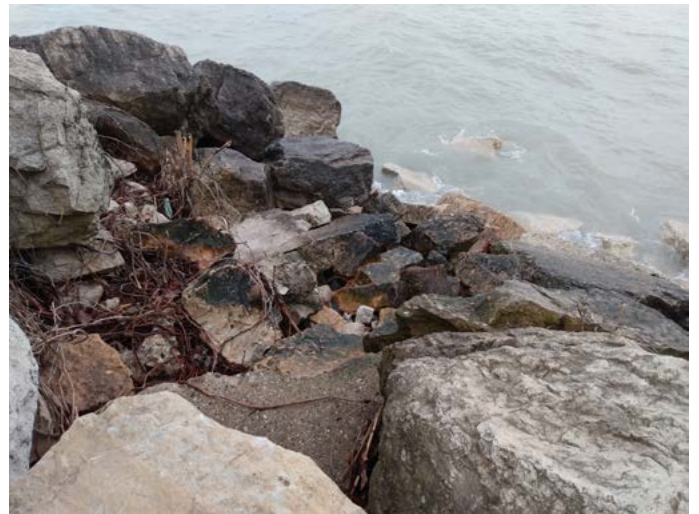
Image 4: Varying stone sizes along revetment slope

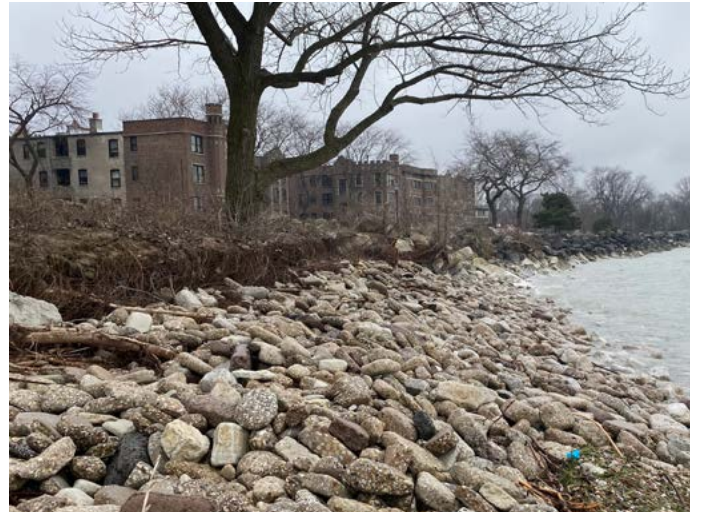
Image 2: Significant erosion at embankment

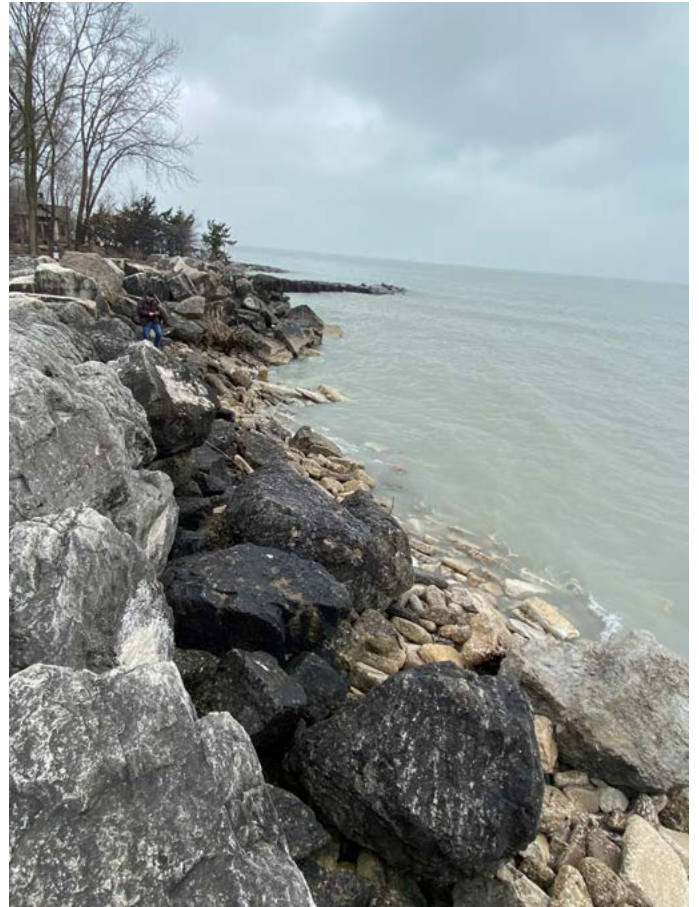
Image 2: Exposed underlayer and section loss throughout revetment

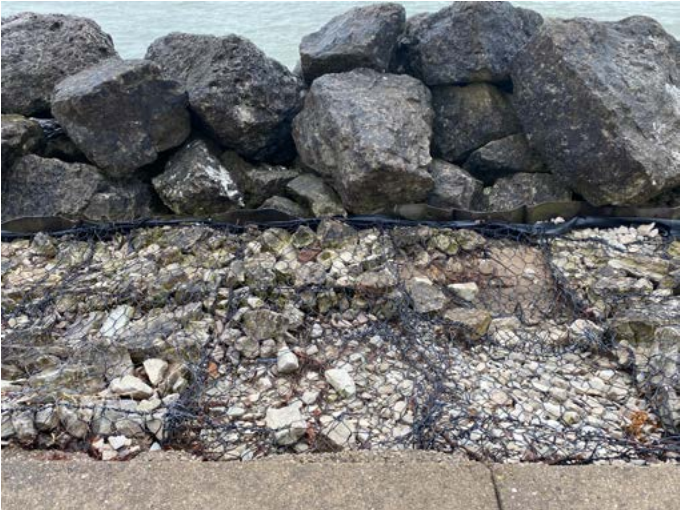
Image 3: Damaged gabions on back side of sheet pile wall

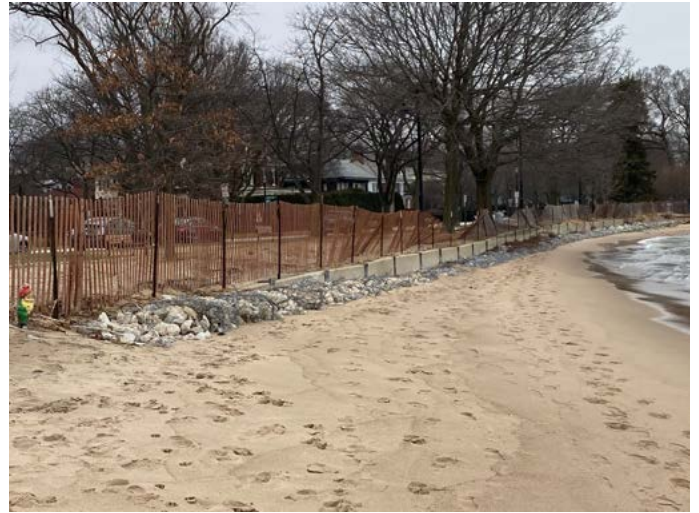
Image 2: Exposed h-pile and concrete wall

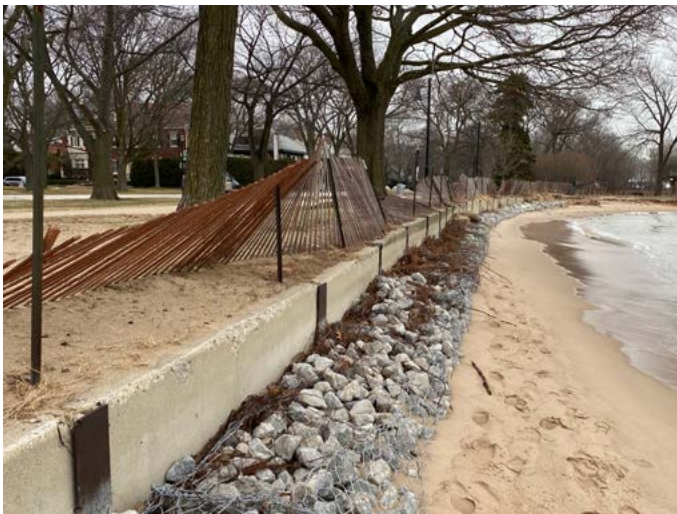
Image 3: Damaged gabions along wall

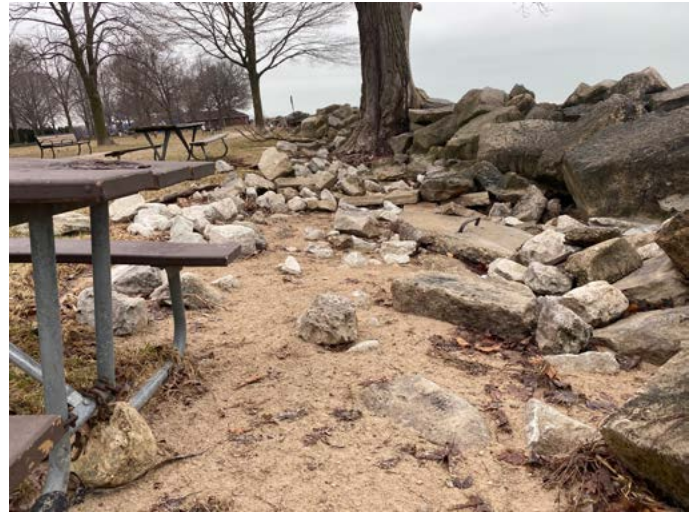
Image 2: Significant landscape damage and displaced stone

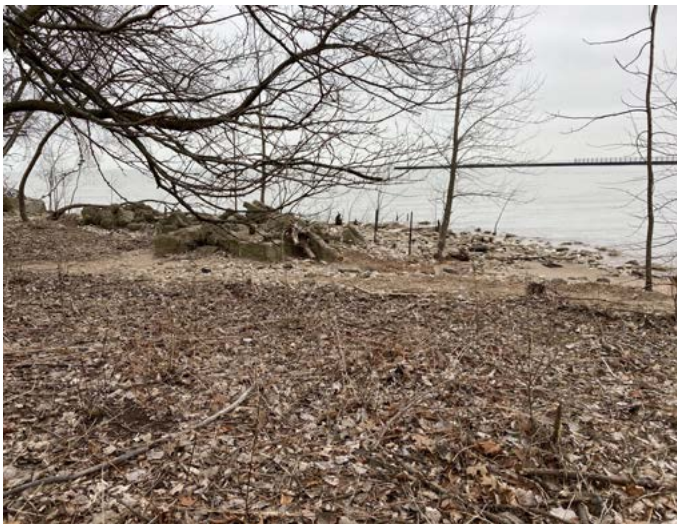
Image 3: Small stones covering beach

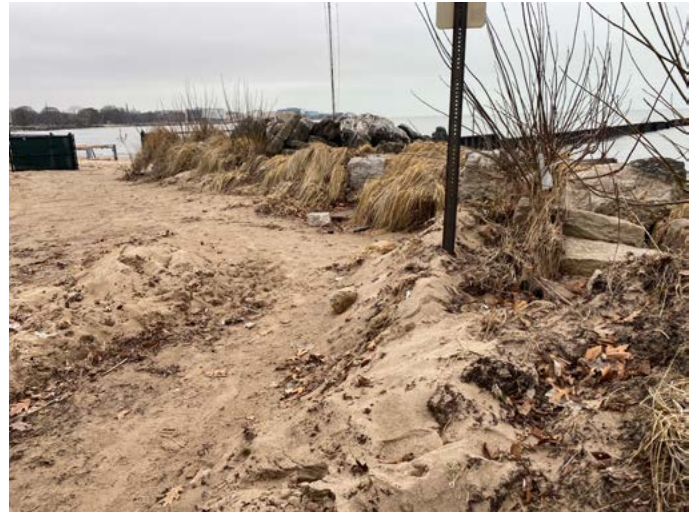
Image 2: Sand transport into driveway

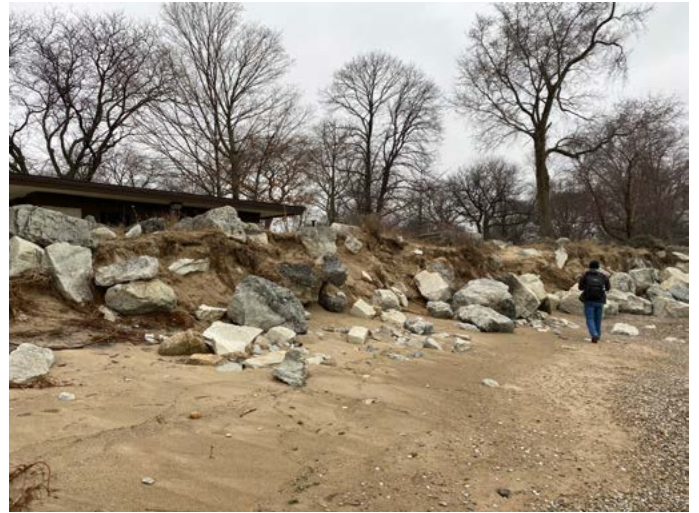
Image 2: Large slope failure with scattered stone

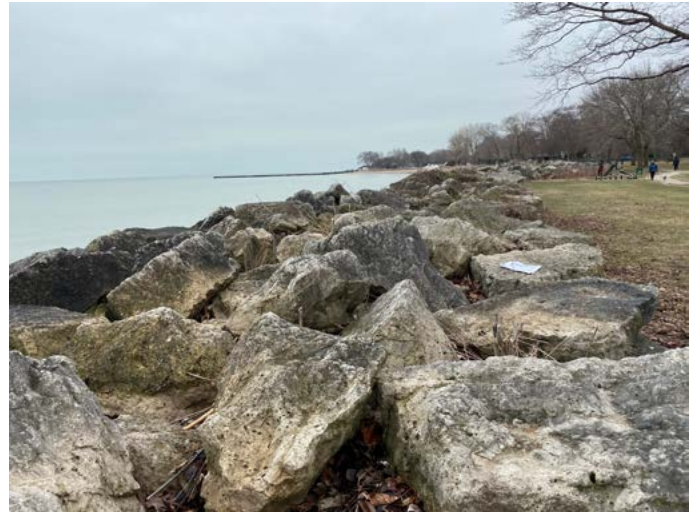
Image 2: Widening revetment crest

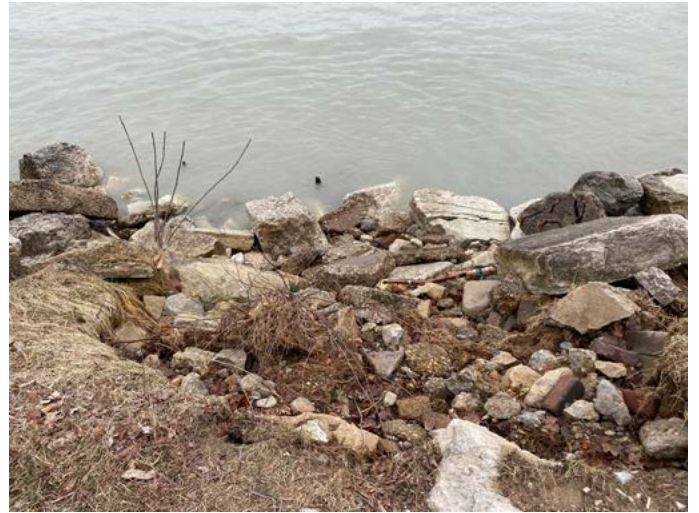
Image 2: Section loss and exposed underlayer

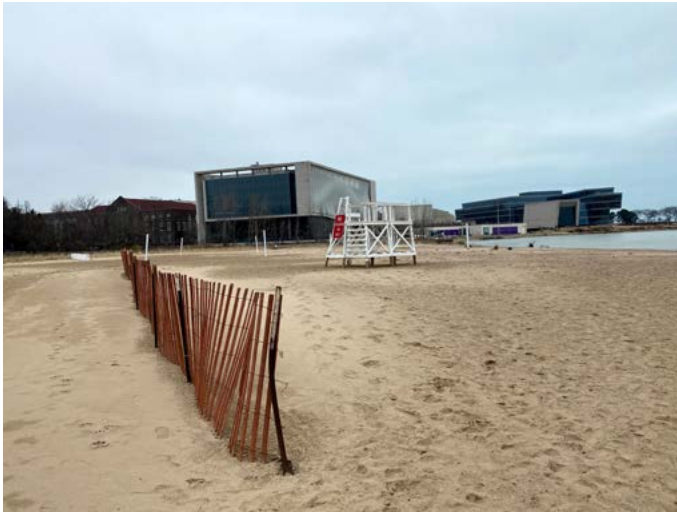
Image 1: Beach in overall good condition

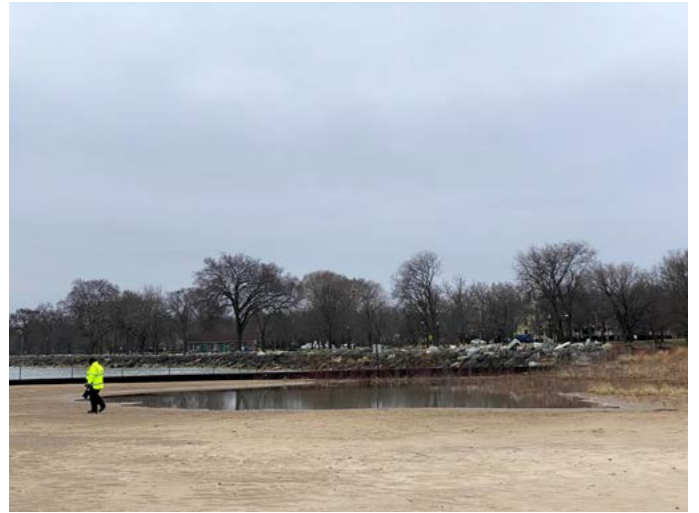
Image 2: Ponding observed at southern corner of beach

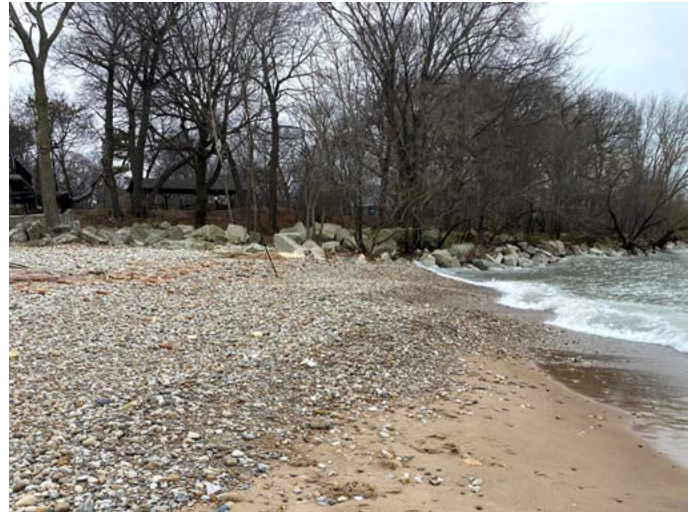
Image 2: Significant stone buildup and beach narrowing
