CITY OF EVANSTON

**SHORELINE
IMPLEMENTATION
ROADMAP**

SMITHGROUP

10/16/2020

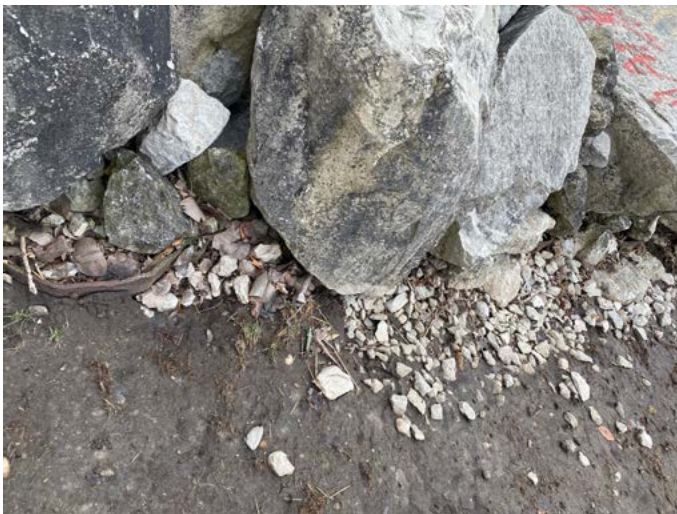
Image 3: Erosion and exposed sheet pile wall at back of revetment

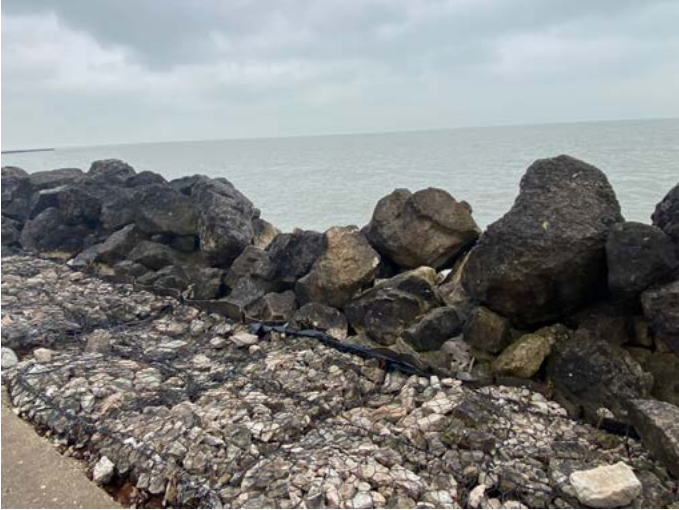
Image 2: Section loss in revetment crest

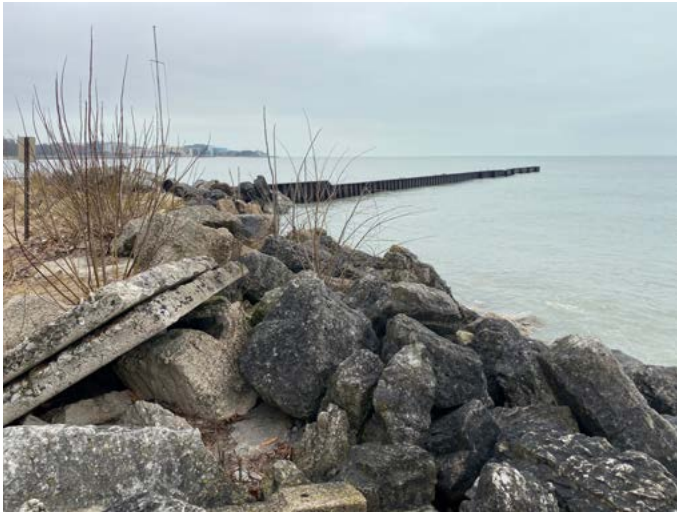
Image 1: Steep revetment slope

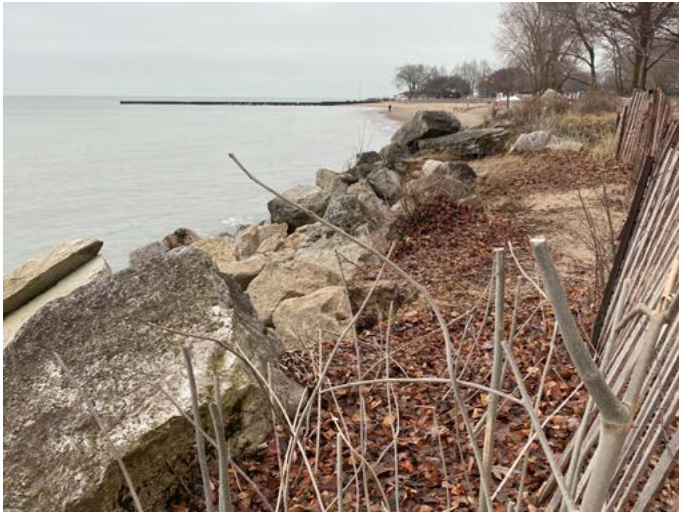
Image 1: No significant revetment crest

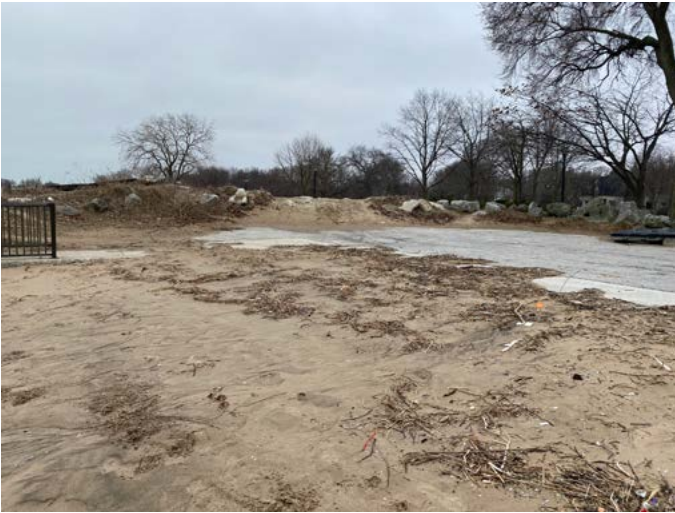
Image 1: Sand buildup at driveway

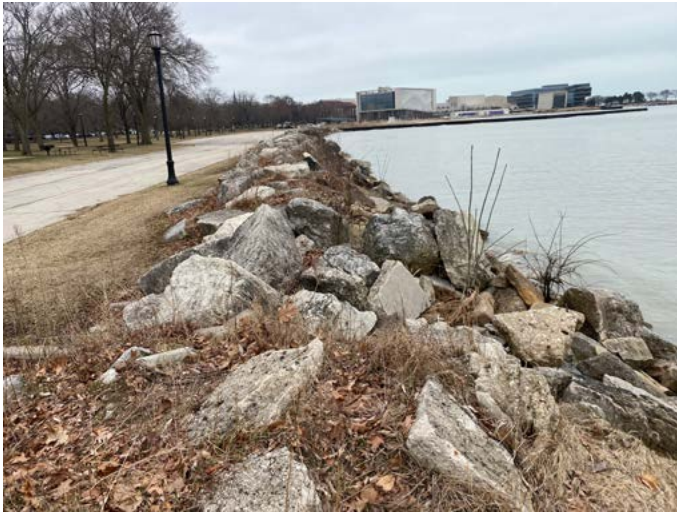
Image 1: Variable amount of stone at revetment crest
