CITY OF EVANSTON

**SHORELINE
IMPLEMENTATION
ROADMAP**

SMITHGROUP

10/16/2020

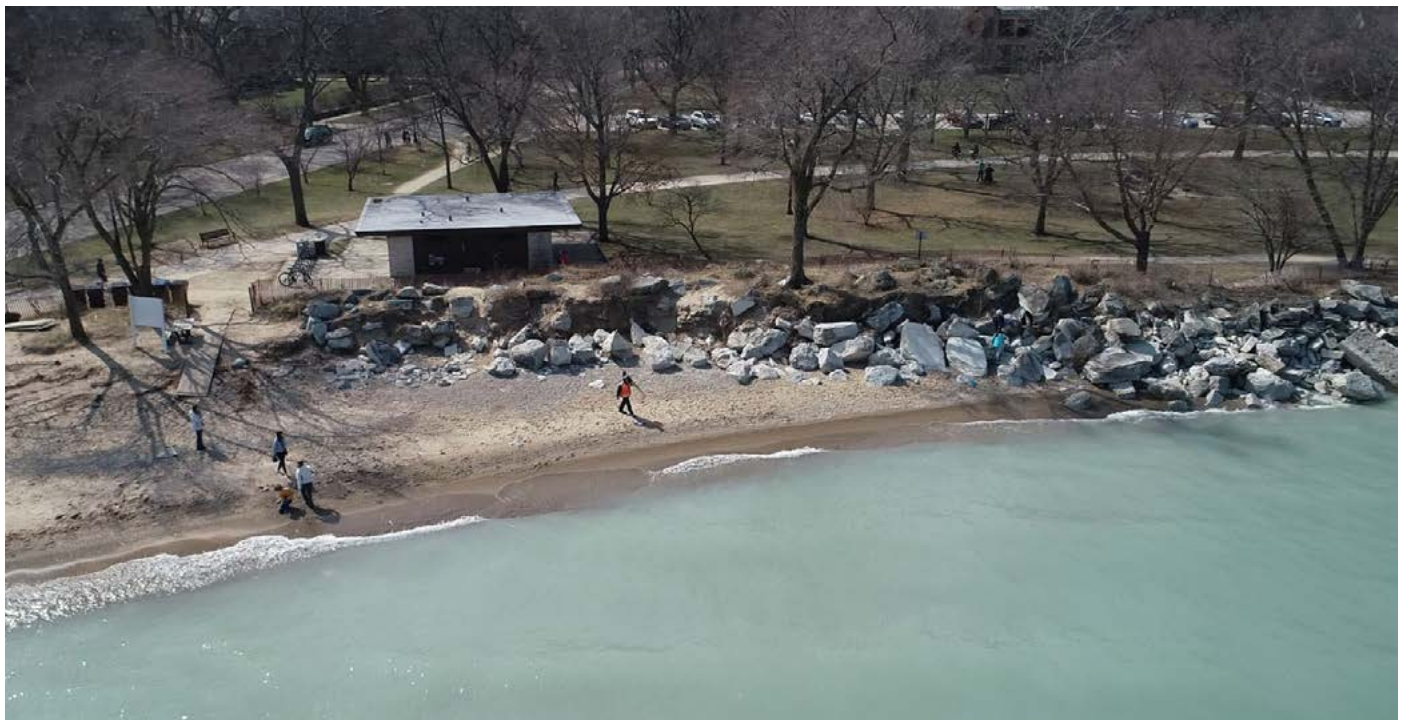
GREENWOOD STREET BEACH - NORTH:

Condition: Narrow dry beach width with a relatively steep beach profile above the water line. Significant bluff damage with a near vertical scoured slope, above head high, with scattered large stone lakeward of the bluff. Cobble and gravel size material are also present near the water line. Scoured bluff presents a potential safety concern to pedestrian in the vicinity of the toe of slope. Low beach crest and width can be easily overtopped during storm events.

- Recommendation - Revetment stabilization and temporary flood barriers
 - Stabilize and add new armor stone to the revetment immediately in front of the building.
 - Install temporary flood protection (e.g. “TrapBag” barriers) extending south from revetment to limit overtopping damage, and reduce wind-blown sand transport.

In the future, consider dune establishment and/or permanent barrier to reduce overtopping at the beach, and new structure north of the beach to hold larger beach.

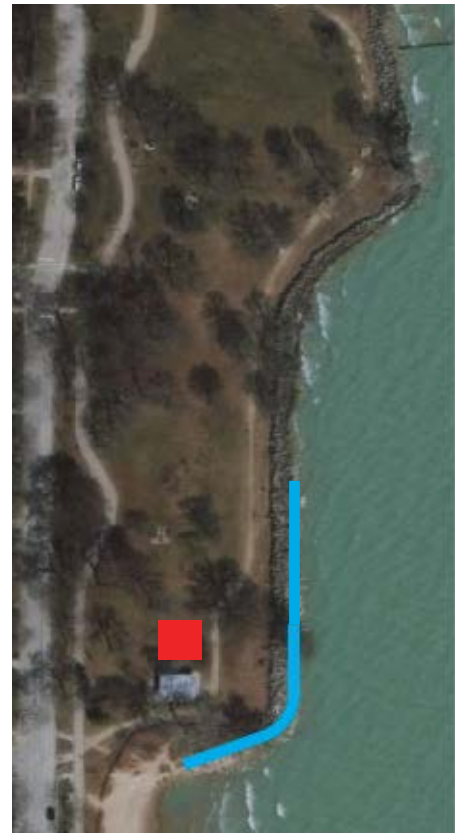
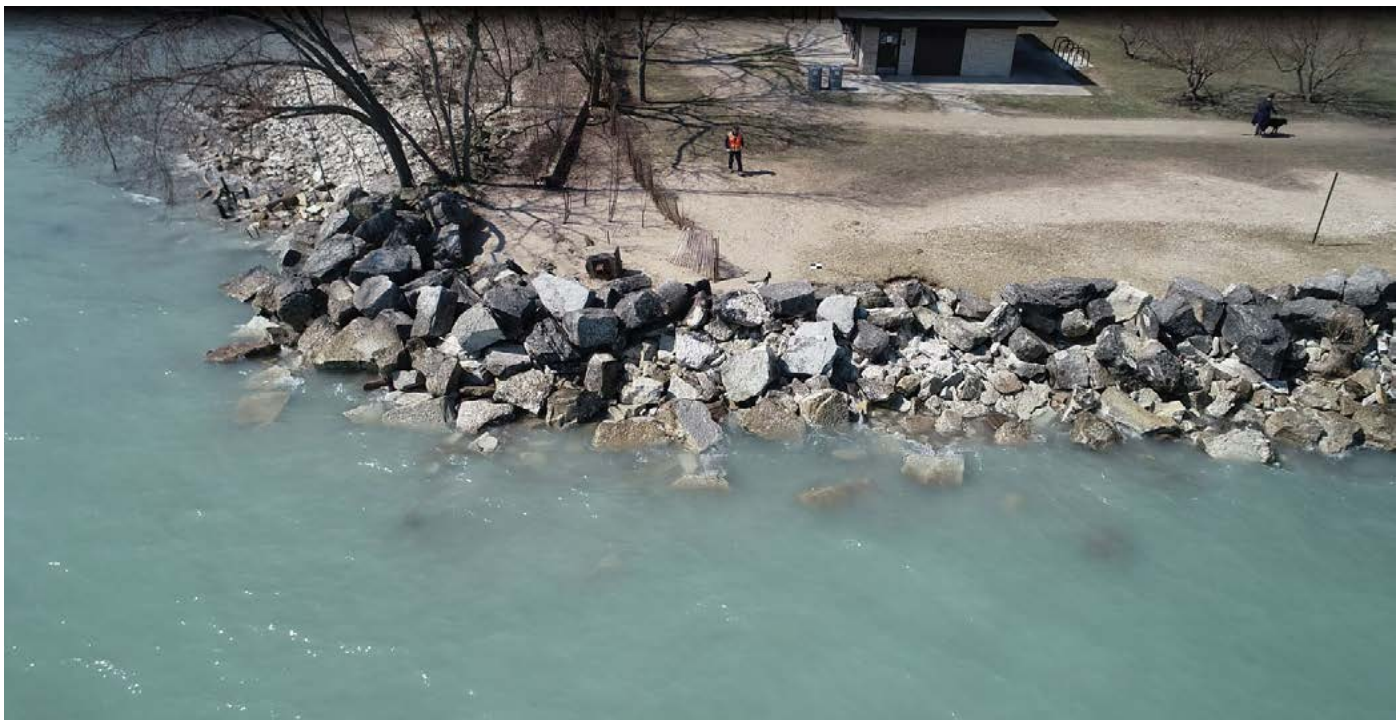
ELLIOT PARK – SOUTH :

Condition: Loss of stone on slope and at the top of bank resulting in significant overtopping of the shoreline and flooding of the adjacent park and facilities. Overtopping results in erosion of the landward side of the revetment, transport of sand and other debris into the adjacent park facilities and ponding of water in large portions of the park. Scour at the landward limit of the revetment has the potential to undermine the revetment while the other impacts of overtopping present a maintenance and potential safety concern to park users.

- Recommendation - Revetment stabilization and temporary flood barriers
 - Stabilize existing armor stone above the water line
 - Install temporary flood protection (e.g. “TrapBag” barriers) extending from north end of Lee Street Beach to approx. mid-point of Elliot Park

In the future, full revetment rehabilitation likely required.

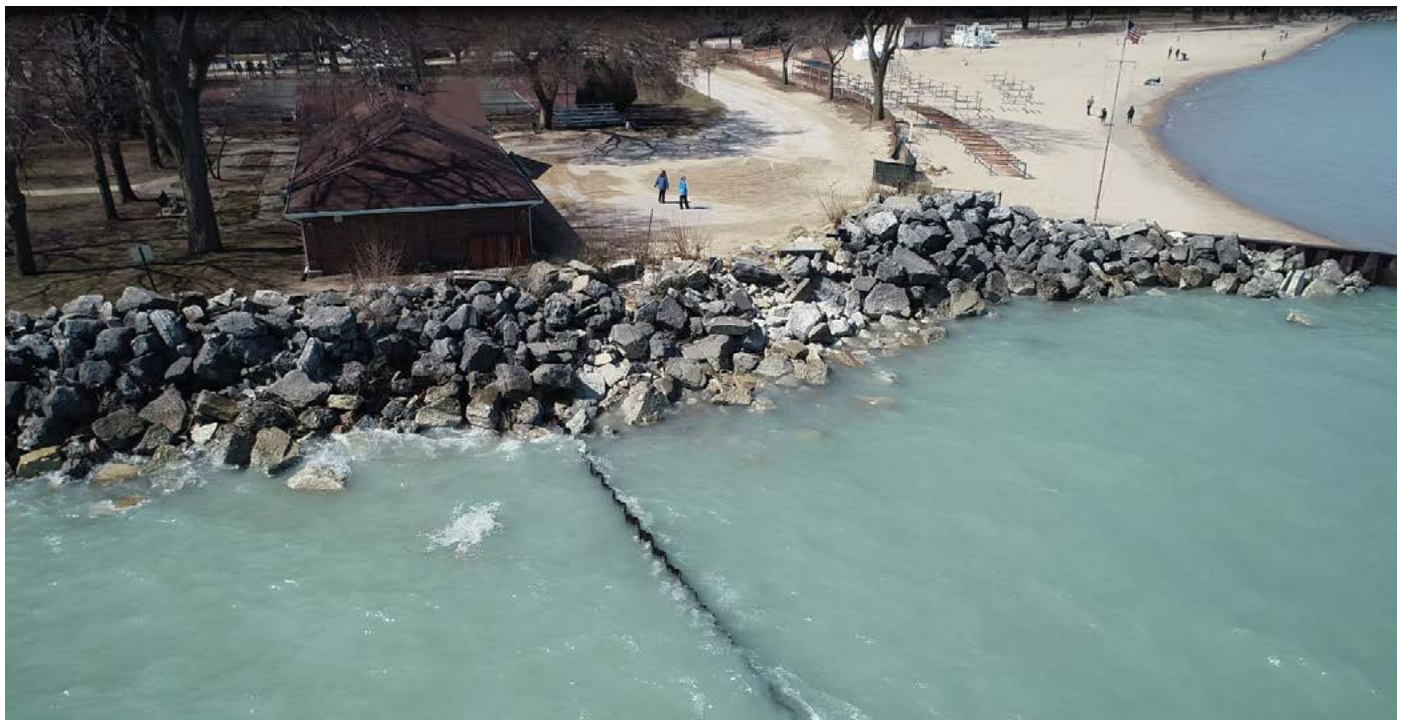
DEMPSTER STREET LAUNCH FACILITY:

Condition: Loss of stone on slope and at the top of bank resulting in significant overtopping of the shoreline and flooding of the adjacent park and facilities. Overtopping results in transport of sand and other debris into driveway and the potential of flooding operations facilities existing for lower frequency storm events.

- Recommendation - Revetment Rehabilitation
 - Place armor stone on top of the underlayer along the slope as well as at the top of bank
 - Increase the height of the top of bank protection
 - Establish slopes of 2:1 or flatter

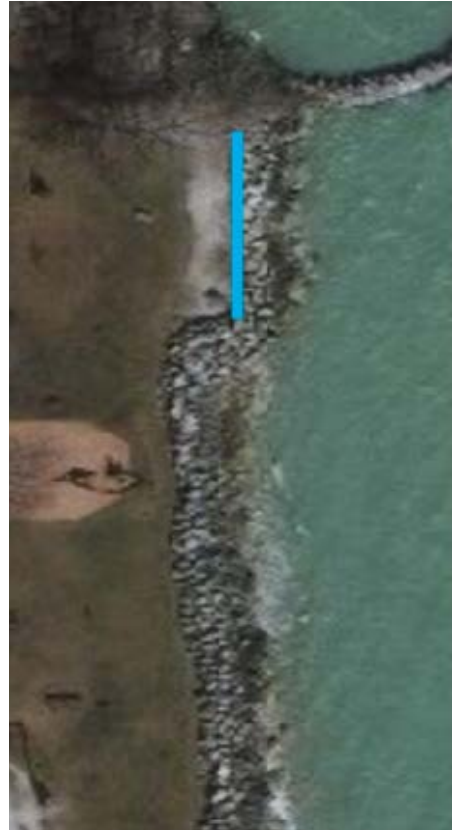
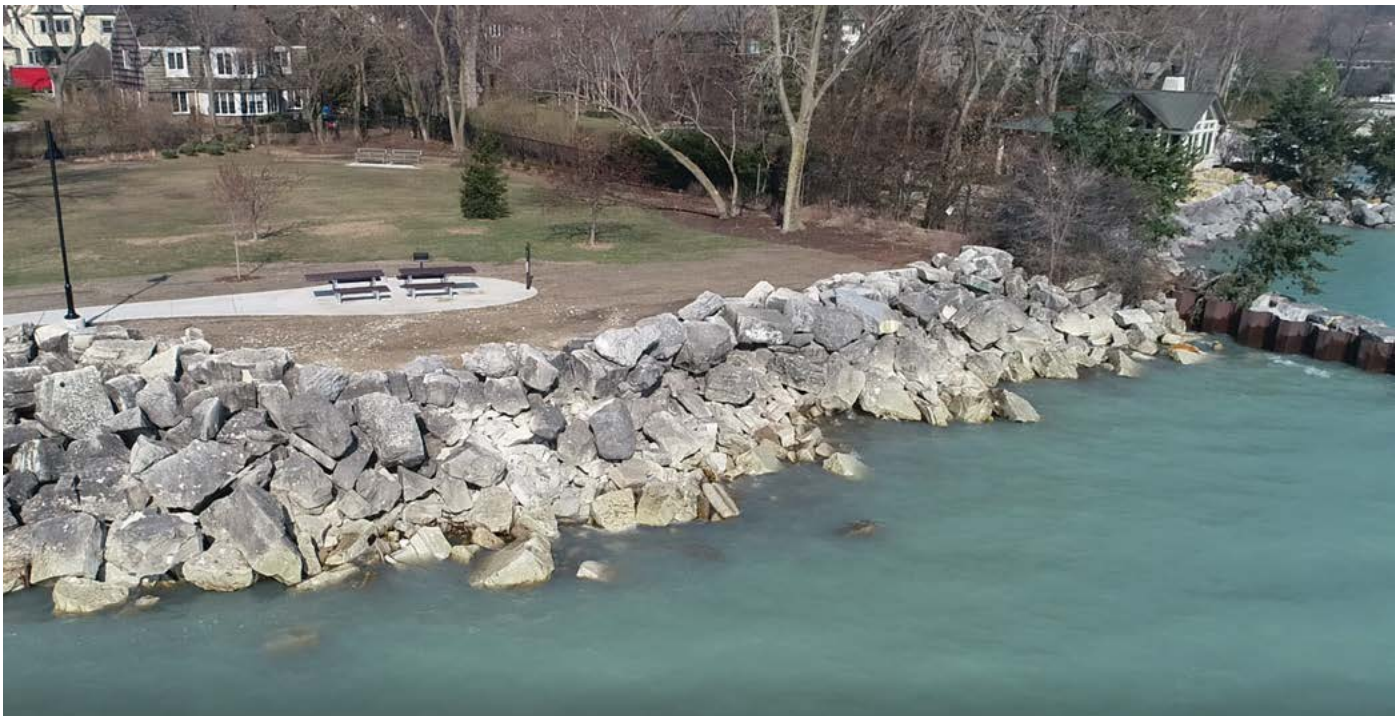
GARDEN PARK – NORTH:

Condition: Loss of stone on slope and lack of top of bank protection resulting in steepened shoreline profile and the potential for significant and frequent overtopping at north end of the park. Erosion to vegetated areas landward of the existing revetment have occurred exposing the presence of a sheet pile wall landward of the existing revetment. Overtopping during storm events presents a potential for frequent repair of vegetated space landward of the shoreline.

- Recommendation - Revetment Rehabilitation (Northern Portion)
 - Place new armor stone and underlayer on the land side to increase the height and width of the revetment crest.

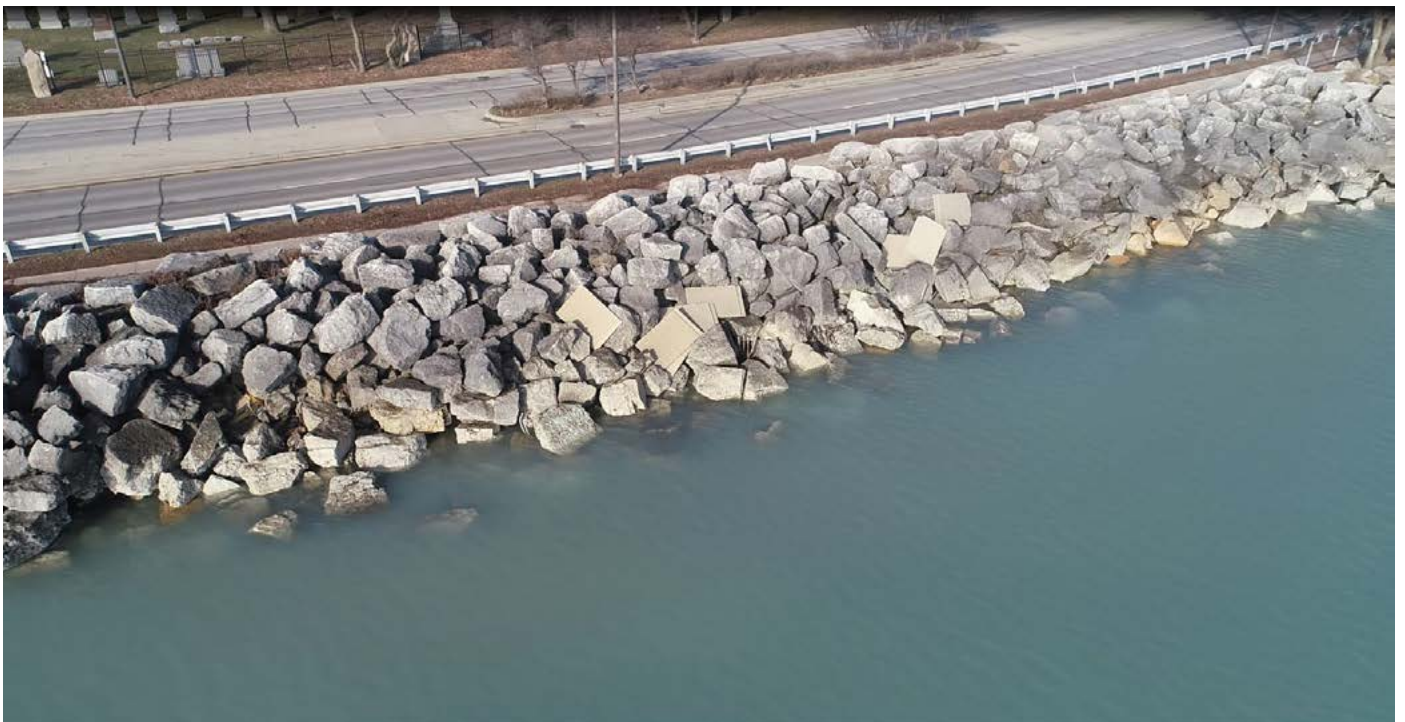
SHERIDAN ROAD REVETMENT:

Condition: Loss of stone on slope and at the top of bank resulting in significant overtopping of the shoreline and exposure of erodible materials. Shoreline is subject to further erosion which may present a risk to roadway stability if erosion continues. Overtopping during storm events presents a potential safety risk to motorists and pedestrians that utilize the sidewalks and roadway immediately adjacent to the shoreline.

- Recommendation - Revetment Rehabilitation:
 - Fill gaps in existing protection along the slope and top of bank with smaller stone to establish an underlayer
 - Place of armor stone on top of the underlayer
 - Establish slopes of 2:1 or flatter.

Note: This portion of Sheridan Road is under IDOT jurisdiction. Recommend entering dialogue with IDOT to schedule revetment rehabilitation. Consider temporary flood barriers if water levels remain elevated and rehabilitation is delayed.

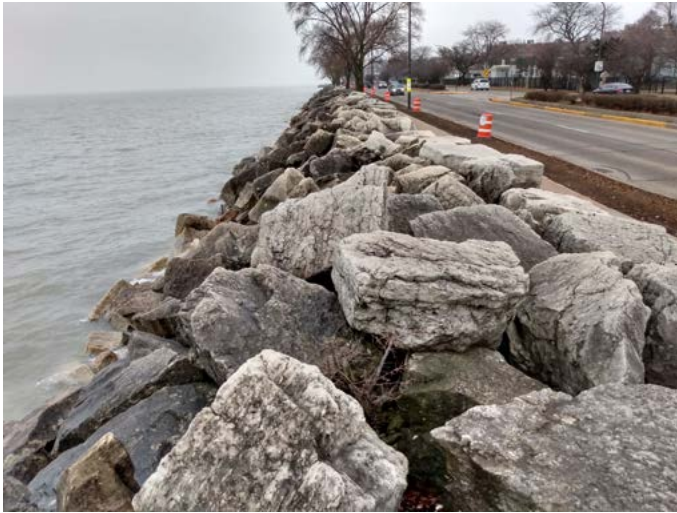
Image 1: Varying revetment slope

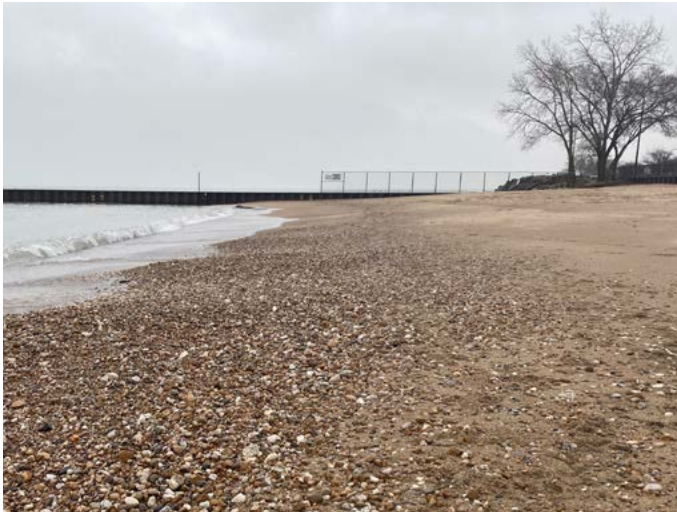
Image 1: Stone and gravel buildup on beach

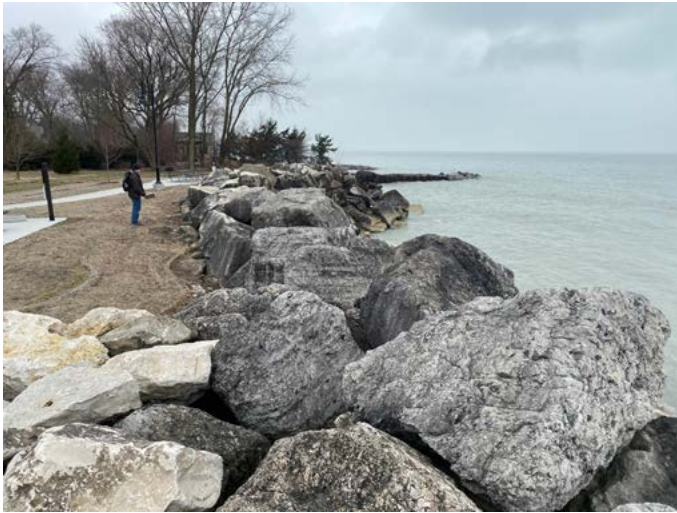
Image 1: Varying width in crest protection

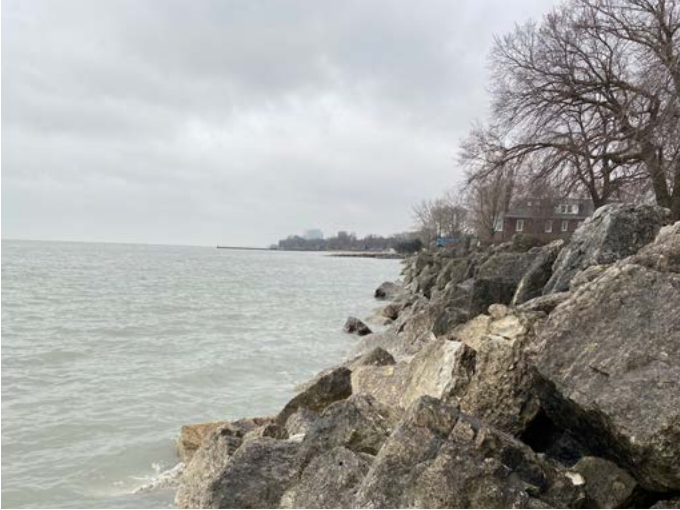
Image 1: Revetment stone stacked at near vertical slope

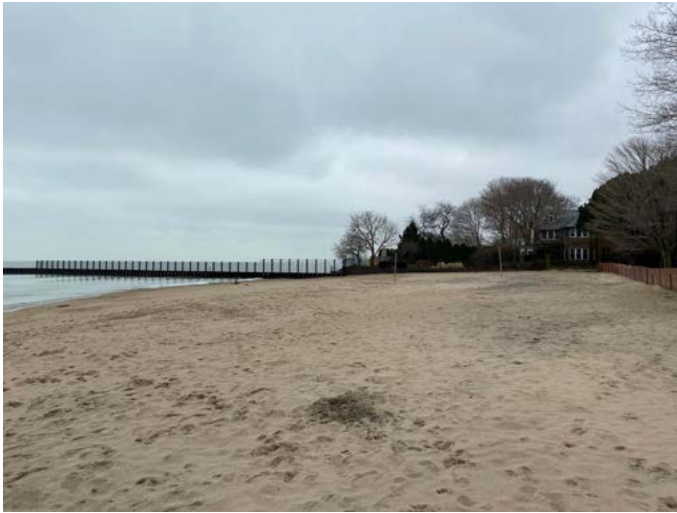
Image 1: Lee Street Beach width

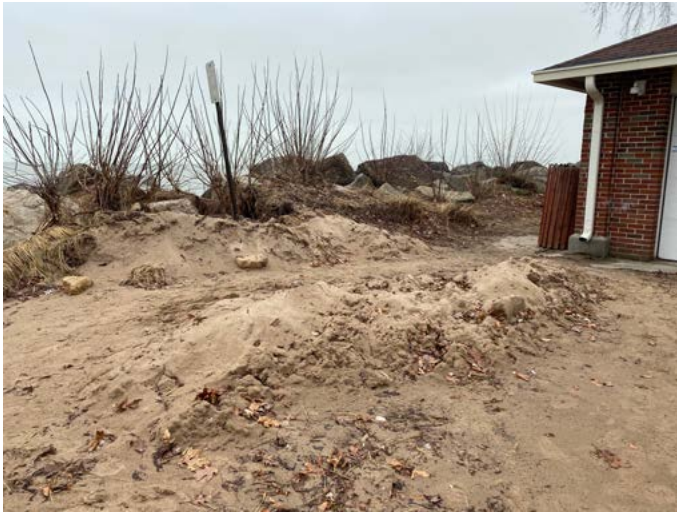
Image 1: Sand transport into driveway

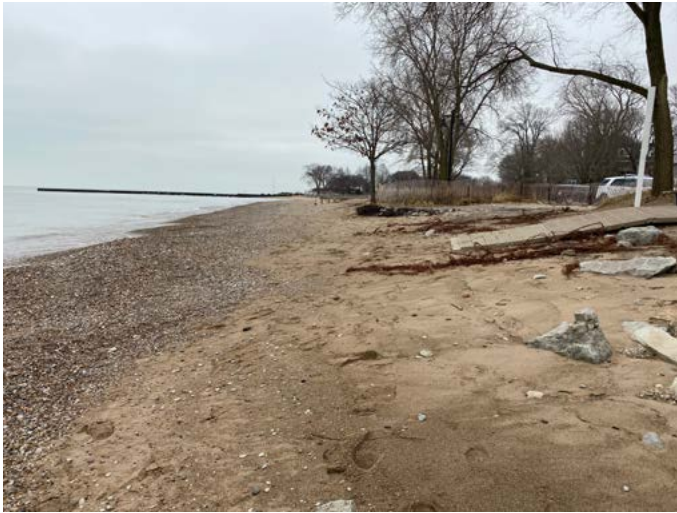
Image 1: Gravel and stone buildup on beach

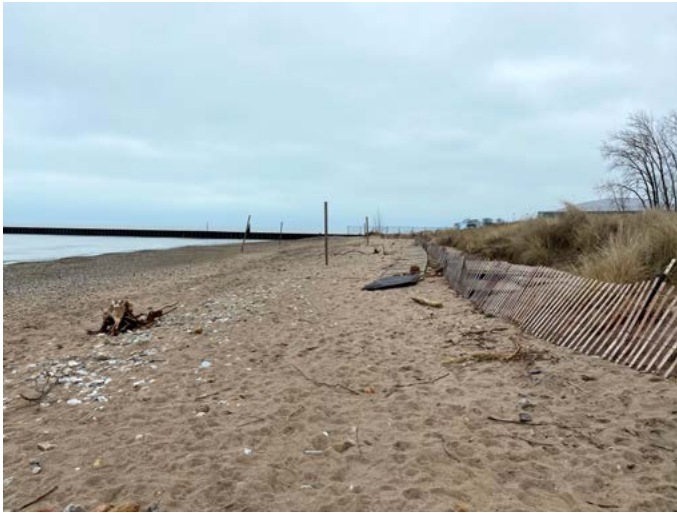
Image 1: Marginal dry beach width
